Re: Middle Ground Shoal Platform, Natural Gas Pipeline Release
Middle Ground Shoal Gas Leak Sampling and Monitoring Plan Summary Report
Sampling Period #4 ending 04/11/2017

ATTACHMENT A
FISH AND WILDLIFE MONITORING SUMMARY REPORT

ATTACHMENT B
WATER QUALITY SAMPLING SUMMARY REPORT

Cook Inlet Water Quality and
Air/Water Interface Sampling
Photo Log: Week 4
4-5-17

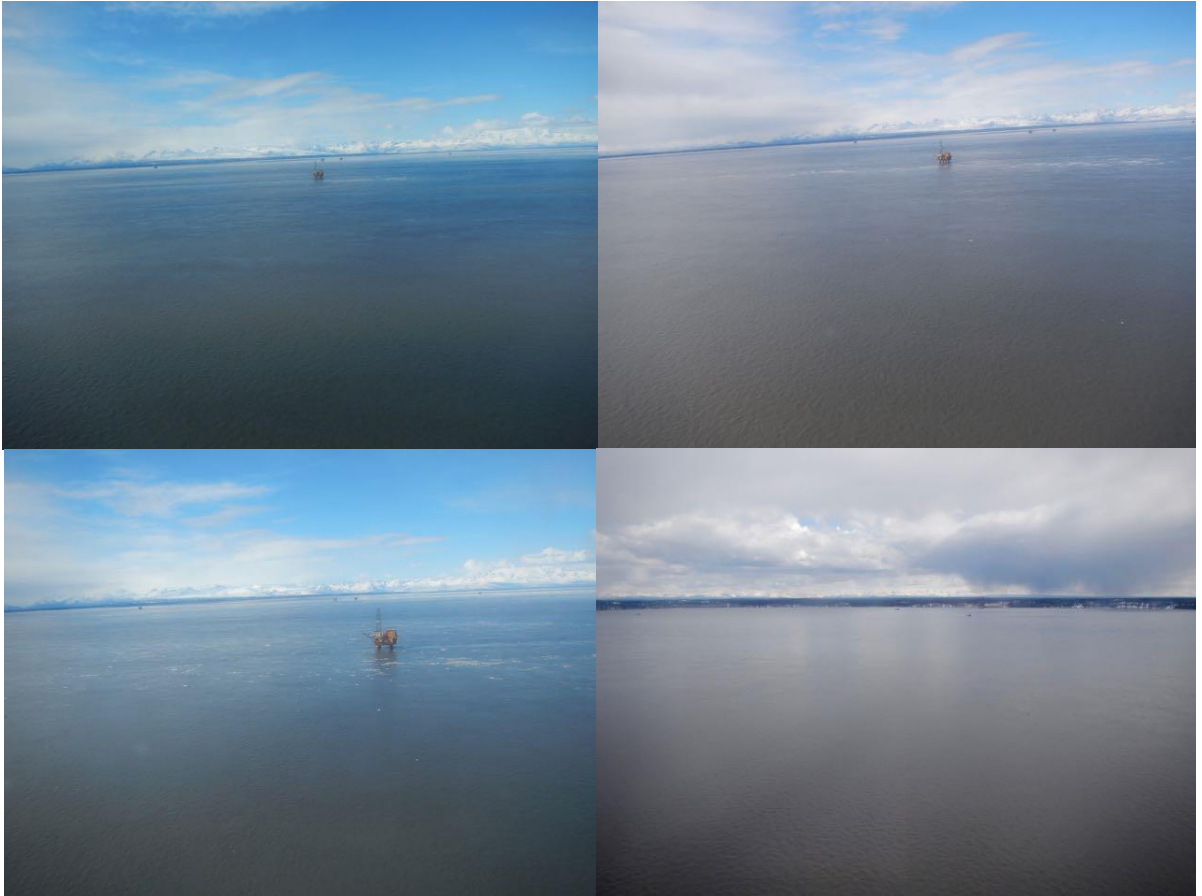
Photograph Log

Photos were taken the vicinity of the leak with a view of Platform A. Flight circles are approximately 0.5 miles apart. The still water has been conducive to detecting flight or dive movements of wildlife.

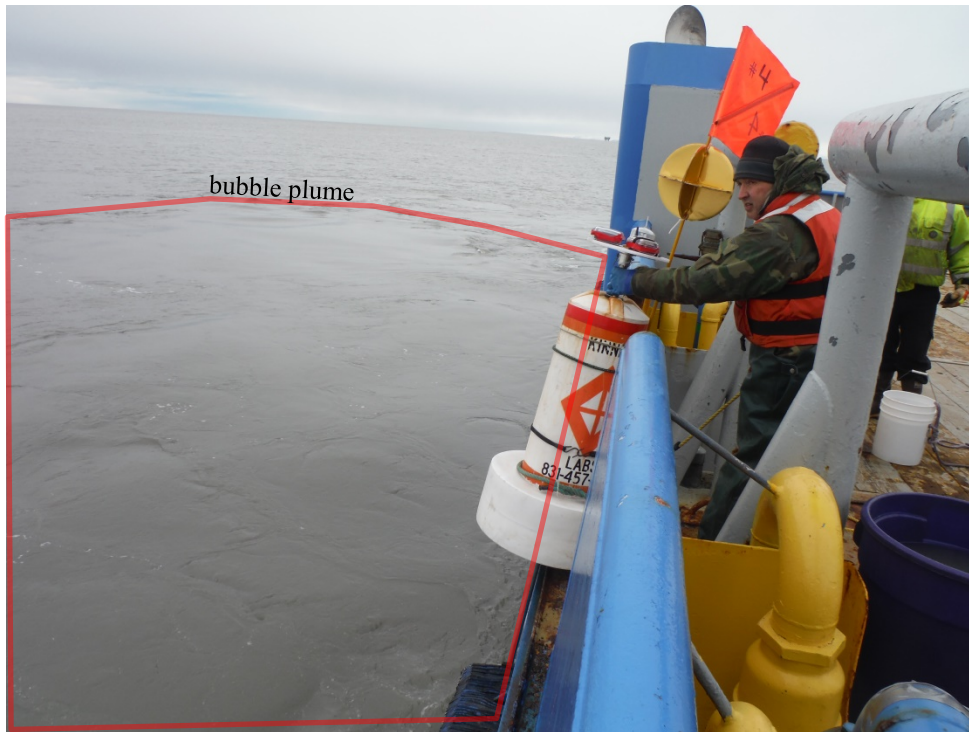
Photo 1: Buoy tethered to boat while drifting through bubble plume

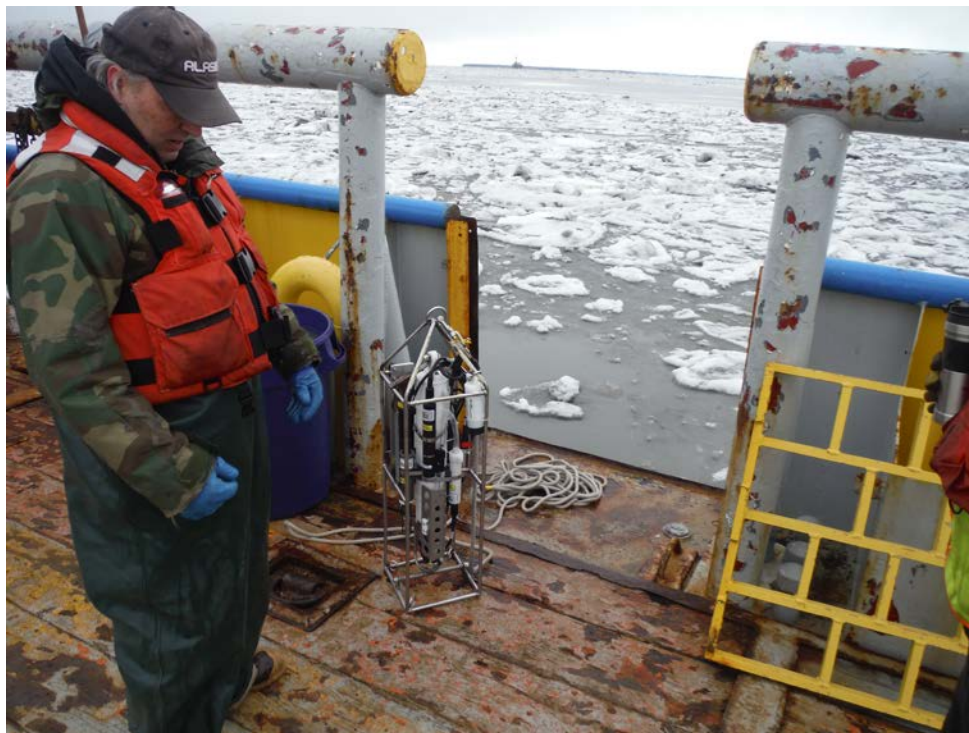
- Ice conditions during the fourth event varied from approximately 5-9 tenths ice cover, with greater variability across the entire inlet. Ice coverage was considerably less, approximately to 0-1 tenths during the flood tide (around 2-5 pm AKDT). Monitoring activities were responsive to these dynamic site conditions, and at one point were temporally suspended due to ice.

Photo 2: Heavy ice conditions temporarily prevented equipment deployment from 12:13 to 12:20.

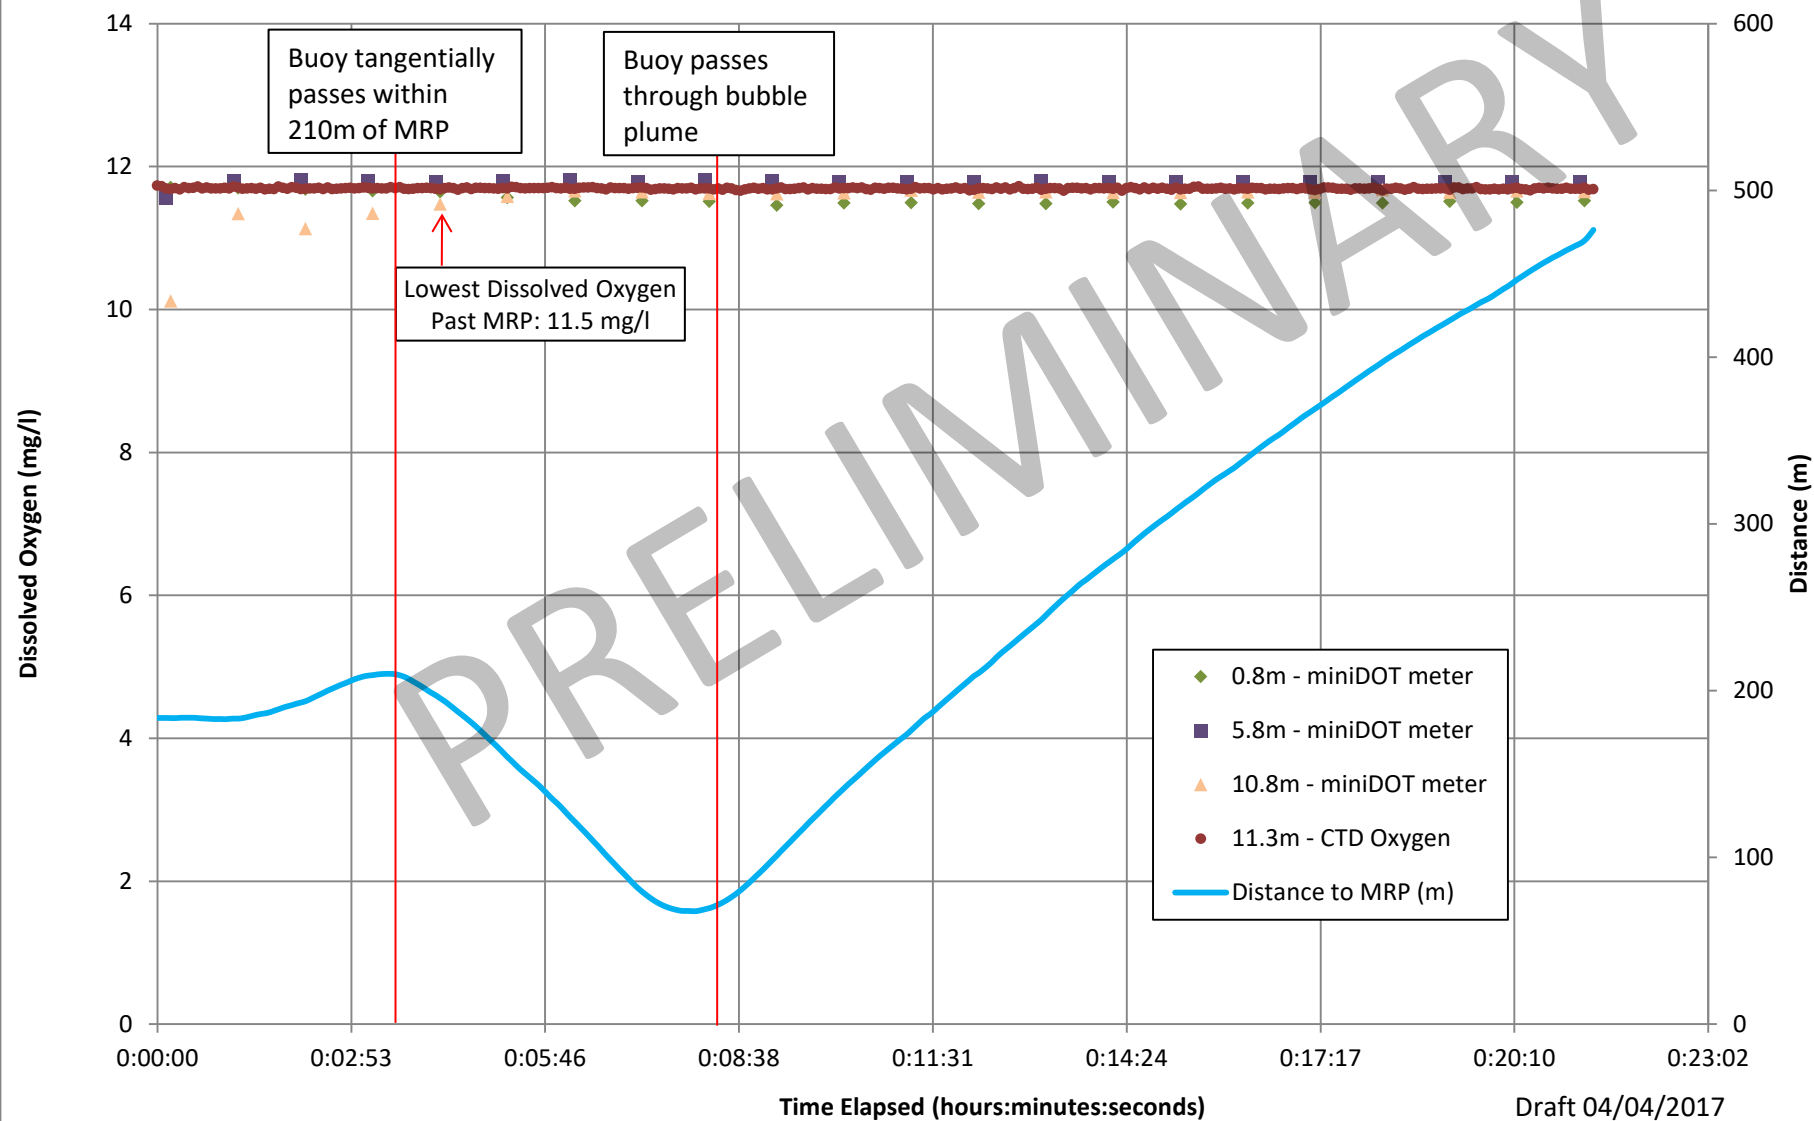
Figure A-7.1a: Buoy Drift #1, April 5, 2017
Dissolved Oxygen Measurements at 0.8, 5.8, 10.8 and 11.3 Meters Depth
Flood Tide

- **Dissolved Oxygen-** The lowest DO value recorded after the sensor had time to stabilize and pass the MRP was 11.5 mg/L during Drift #1 and 11.4 mg/L during Drift #2. There was no significant drop in DO concentrations recorded by the sensors as they passed the MRP, or passed through the bubble plume (Attachment A, Figure A-7.1a and A-7.2a). However, a slight drop on the order of 0.1 mg/L appears evident on the plot of the miniDOT sensor at 10.8 meters, immediately after the buoy passed the bubble plume both times during Drift #2 (Figure A-7.2a). It is noted that during both drifts the miniDOT sensor deployed at the deeper depth (10.8 meters) had some potentially erratic readings during the initial one to three minutes of deployment, which may indicate a sensor stabilization period. This pattern was evident in the DO plots of the deeper MiniDot sensor in previous monitoring events (Weeks 2 and 3), and appears to be typical.

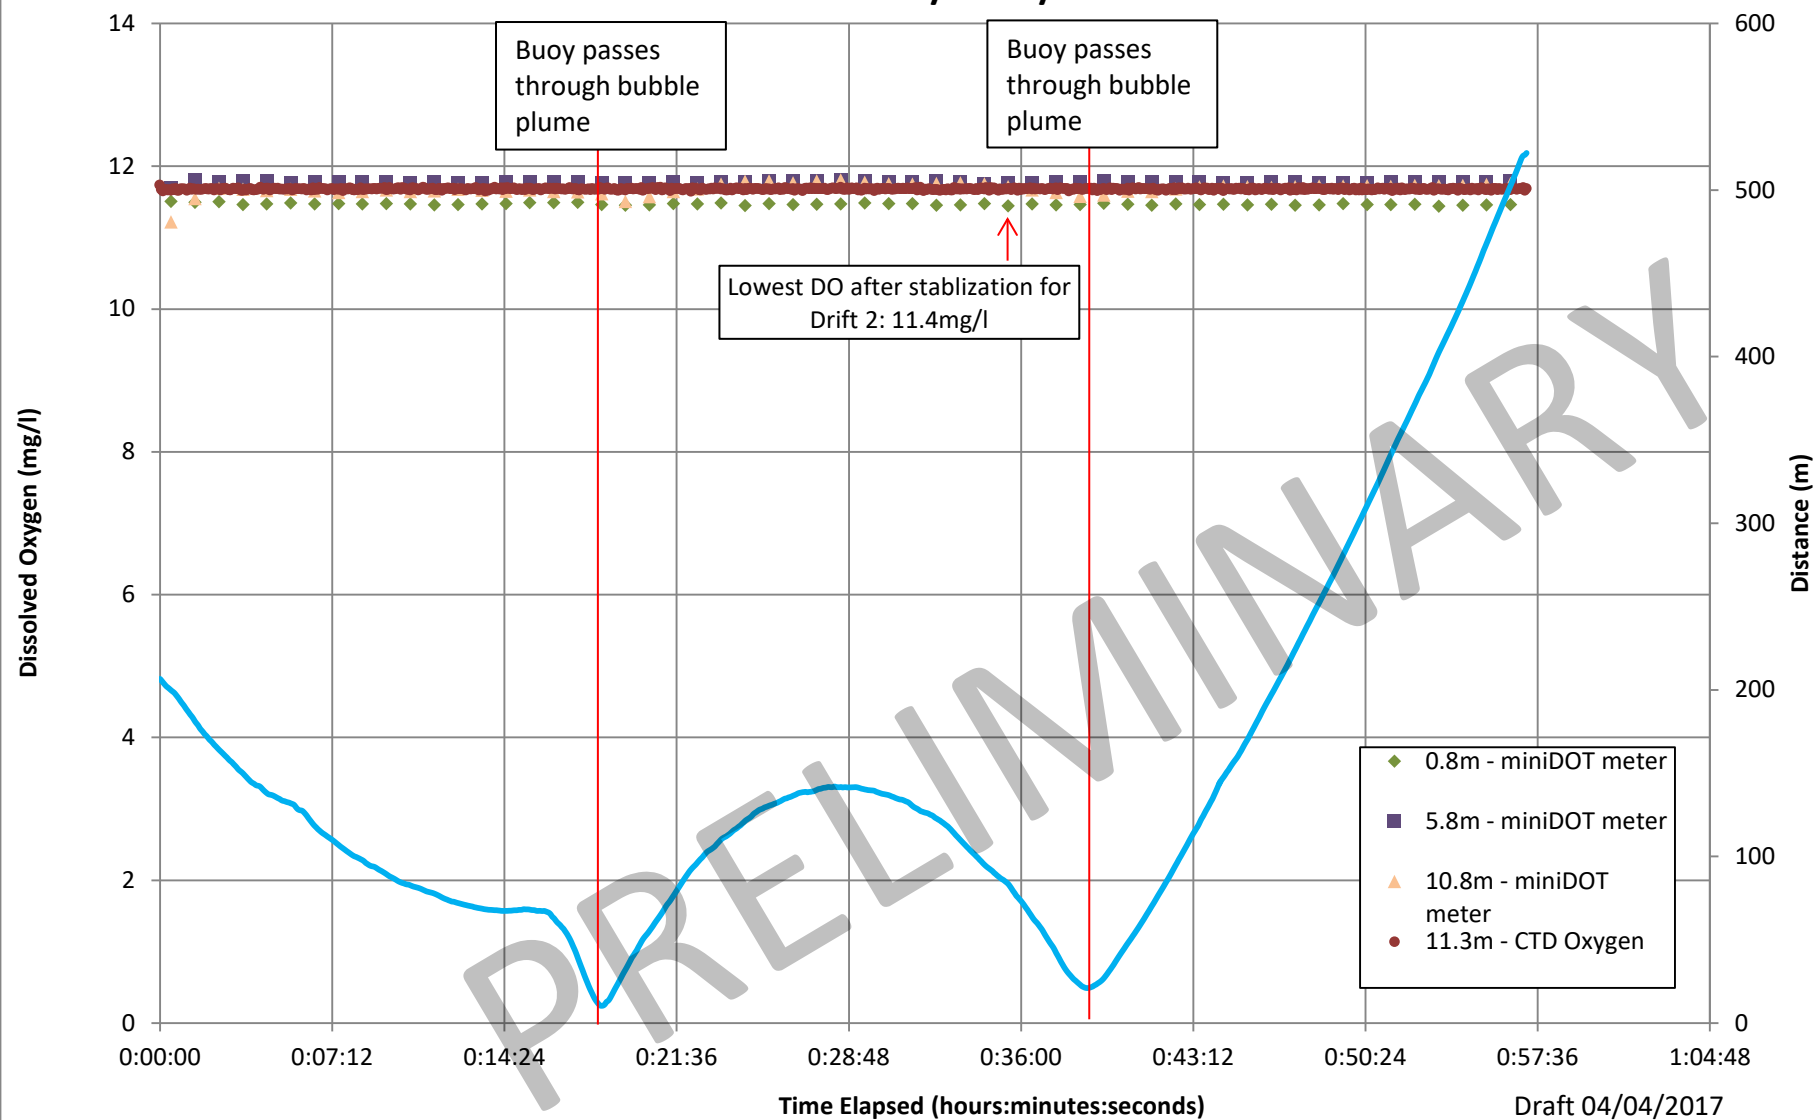
Figure A-7.2a: Buoy Drift #2, April 5, 2017
Dissolved Oxygen Measurements at 0.8, 5.8, 10.8 and 11.3 Meters Depth
Flood/Slack/Ebb Tide

As during previous weeks, the lowest DO concentration measured during both drifts was well above the most stringent regulatory limit for DO in marine waters established in 18 AAC 70. The 18 AAC 70 Alaska Water Quality Standards for marine waters state the surface DO concentration in coastal waters may not be less than 6.0 mg/L for a depth of one meter except when natural conditions cause this value to be depressed. DO may not be reduced below 4 mg/L at any point beneath the surface. DO concentrations in estuaries and tidal tributaries may not be less than 5.0 mg/L except where natural conditions cause this value to be depressed.
